**MT SPEC ROAD AND LITTLE CRYSTAL CREEK BRIDGE
PALUMA**

**CONSERVATION MANAGEMENT PLAN
2011**

Prepared by
IVAN McDONALD ARCHITECTS
for
QUEENSLAND DEPARTMENT OF TRANSPORT AND MAIN ROADS
CONTRACT NO. MR 090046B

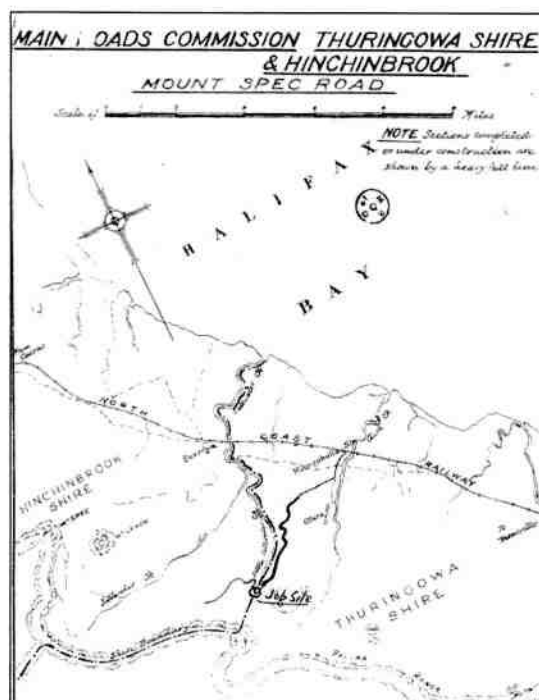
Figure 3 Sketch showing location of Little Crystal Creek Bridge (labelled job site).

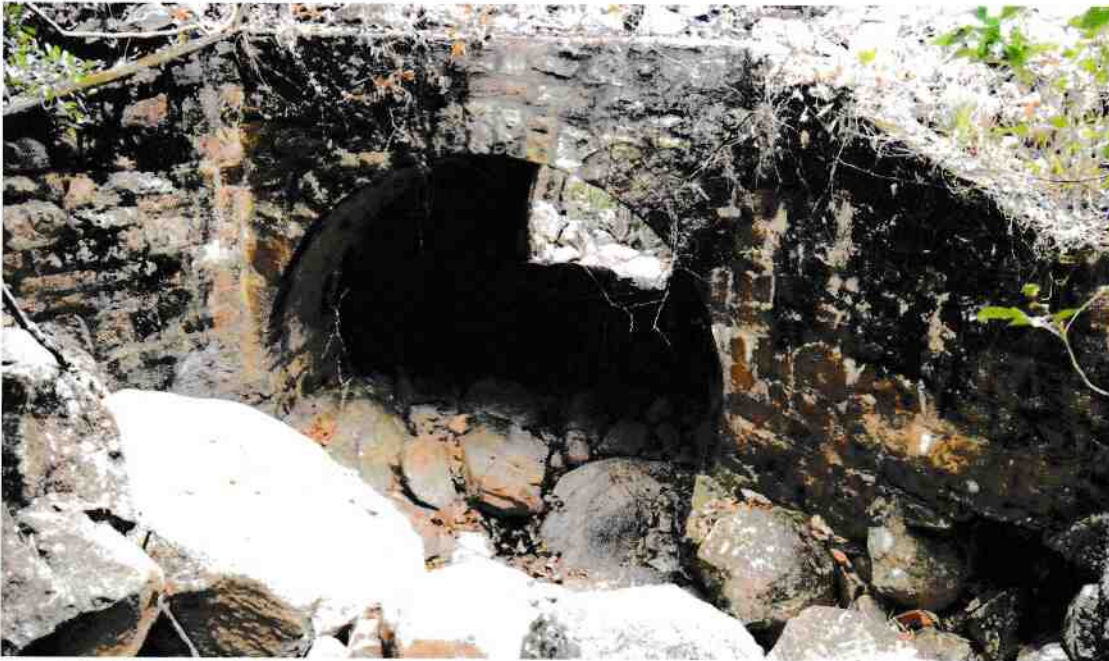
Figure 61 Large culvert headwall constructed in coarsed rubble

Most large culverts incorporate stone-flagged inverts and extensive inlet and outlet headwalls constructed of coarsed rubble masonry in cement mortar. Depending on the topography, large culvert outlets often also incorporate substantial retaining walls constructed of hand-packed random rubble masonry as shown in **Figures 61** and **62**. In many instances, the natural or hewn rock forms part of the culvert structure as headwalls or inverts.

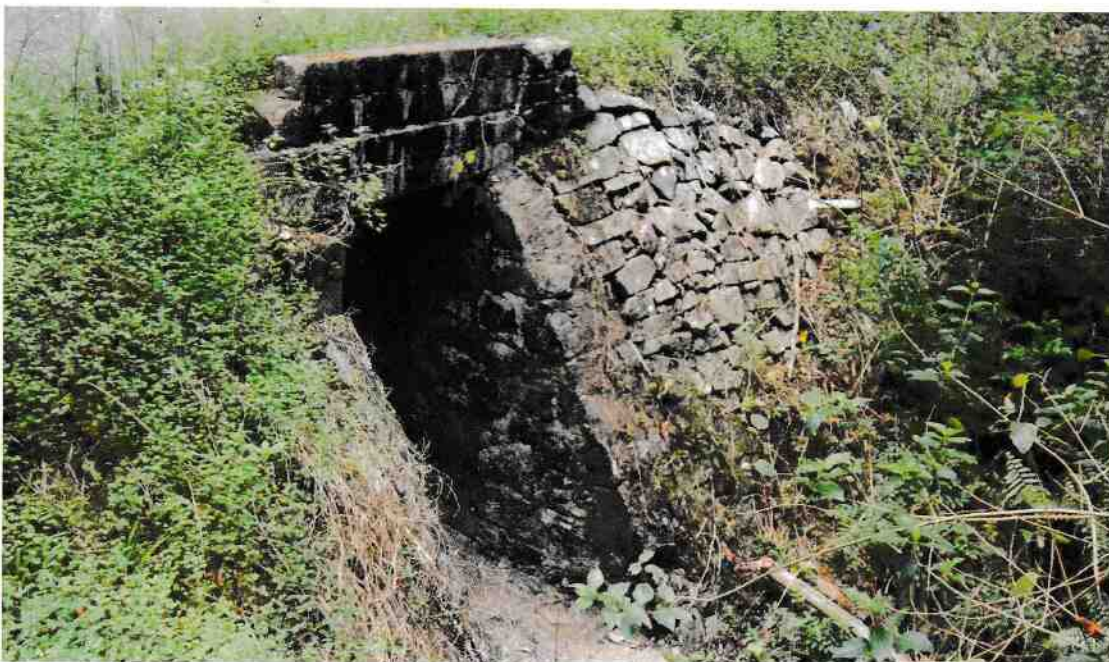
Figure 62 Large culvert headwall incorporating stone retaining wall

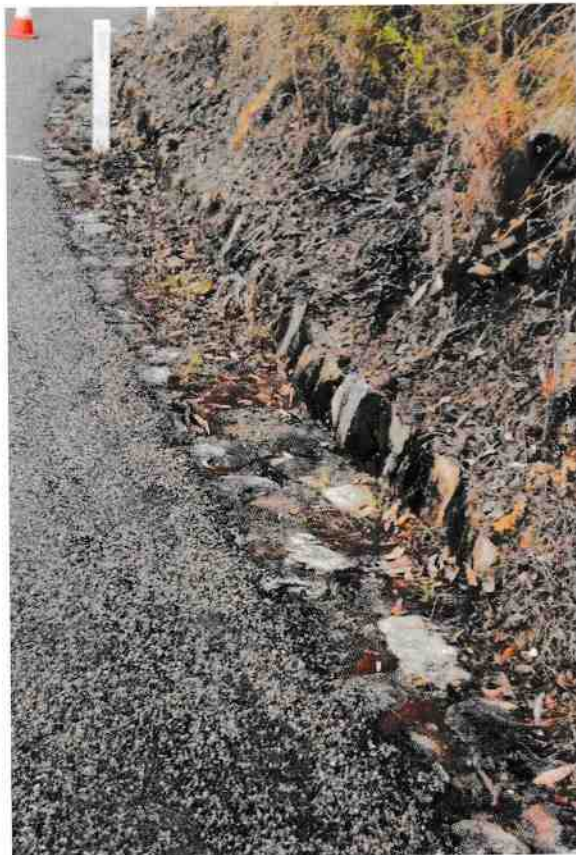
Figure 63 Stone kerbing and channelling

Stone-pitched channelling in lengths greater than 2m, occurs at 56 locations with the longest continuous section also being 144m, uphill of Culvert 207. The total length of intact stone-pitched channelling is approximately 1700m. Intermittent stone-pitched channelling in lengths greater than 2m, occurs at 20 locations and up to 62m, in length uphill of Culvert 119. The total length of intermittent stone-pitched channelling is approximately 500m.

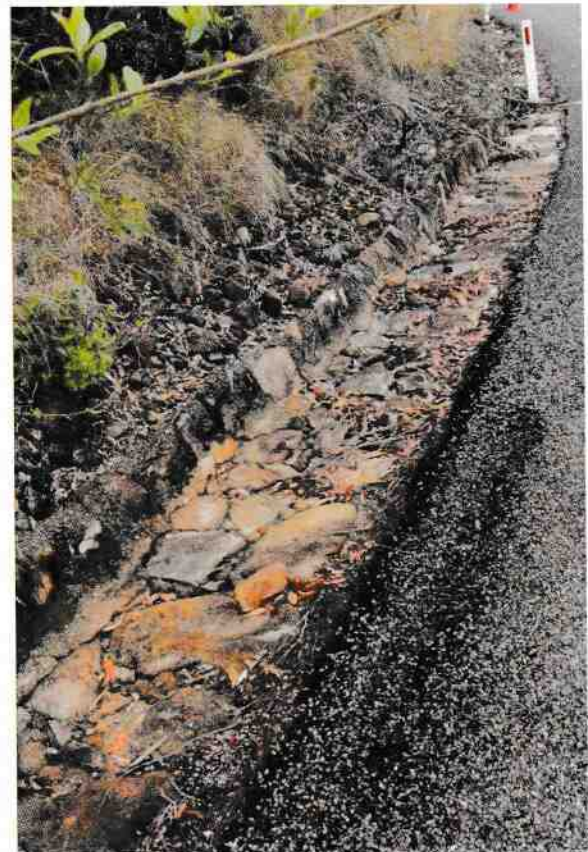
Figure 64 Stone kerbing and channelling

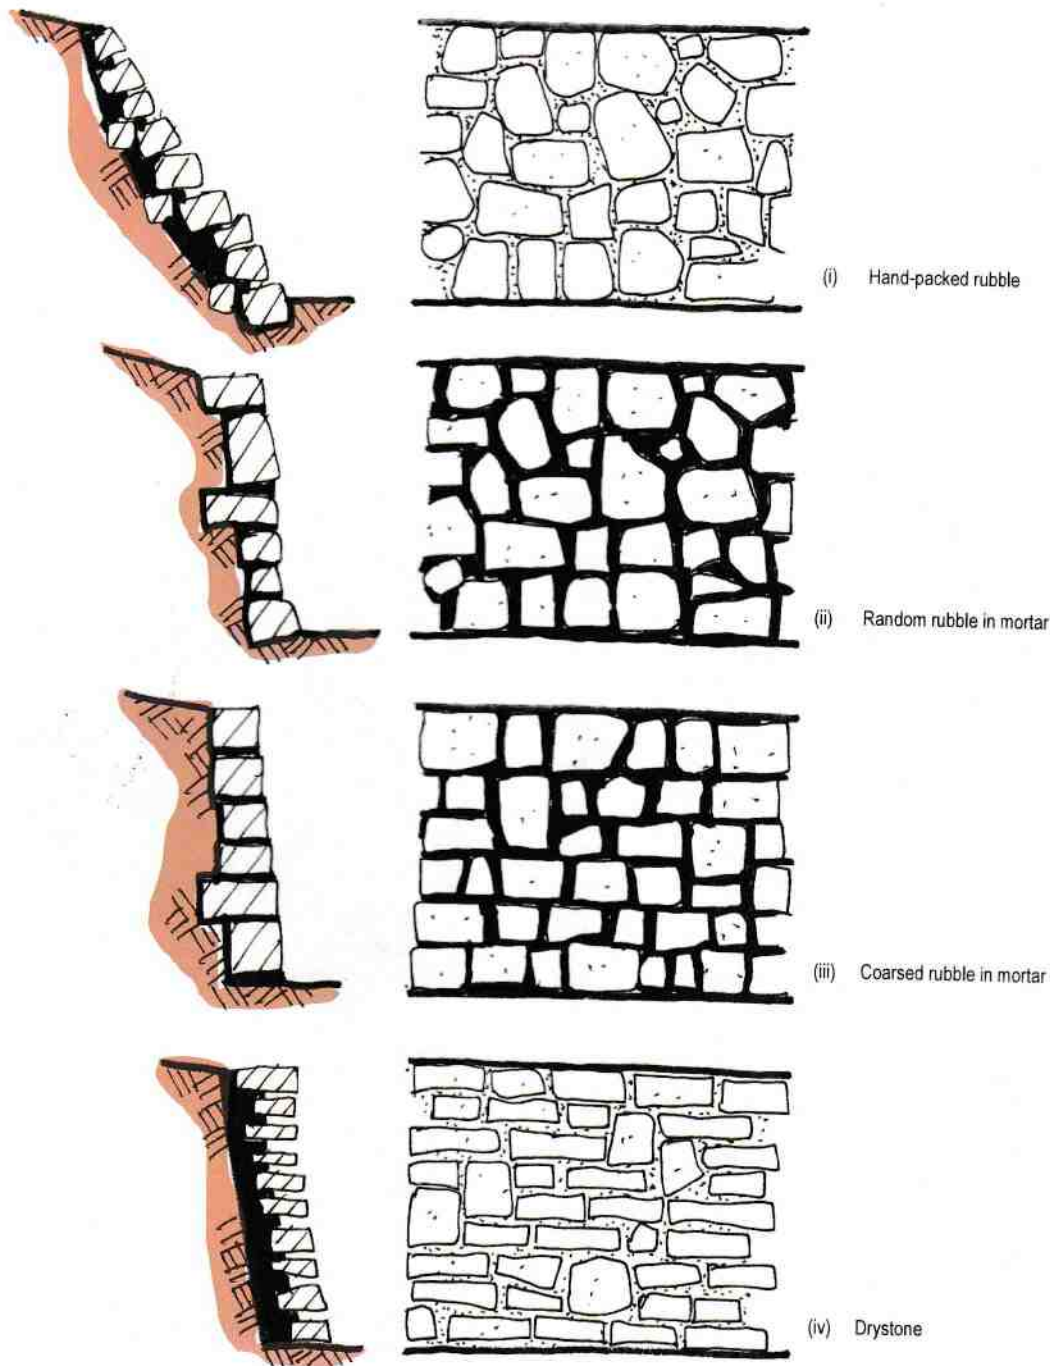
Figure 65 Stone retaining wall types

Figure 65 illustrates an example of this technique.

Of these various techniques, the drystone walling is the most- finely-crafted and most-attractive. It has been used predominantly in small, roadside retaining walls and consists of local stone flags laid in rough courses with unmortared joints. It is likely that the flags are packed in concrete or cement mortar at the rear and are not true "drystone" walls in the strict dry-laid definition of the technique.

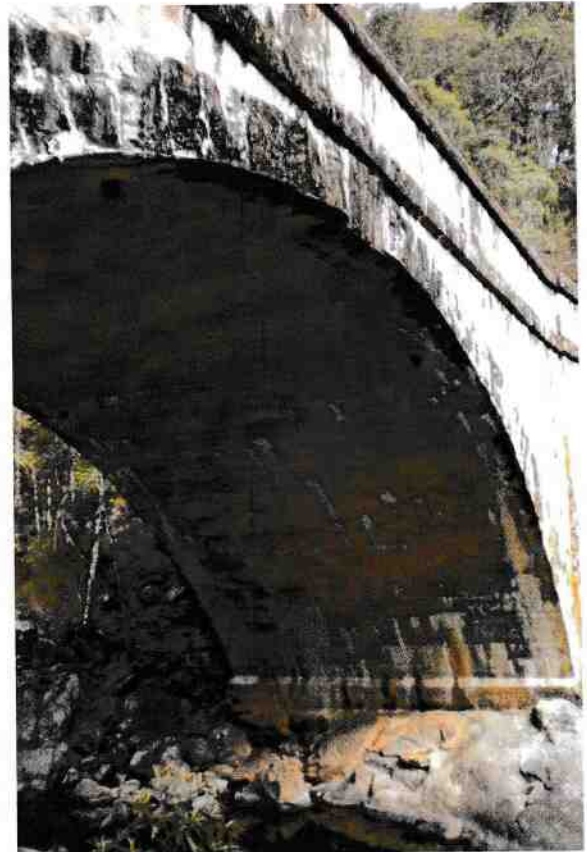
Figure 67 Main bridge

The main feature of the road is the Little Crystal Creek bridge. The bridge spans Little Crystal Creek (originally called Little Saltwater Creek) with a mass concrete arch ring of 60' (18m) span and 17' (5m) height. The arch is cast into concrete skewbacks founded in the natural bedrock. The core of the structure is rock-filled and the upstream and downstream sides are faced with a combination of random and coarsed rubble set in cement mortar. The stone was obtained from cuttings at "Barrett's Bluff" approximately 1.8km uphill of the bridge (in the vicinity of Culverts 120 and 119). This was the only stonework on the road executed by stonemasons.

Figures 66 and 67 illustrate the existing bridge.

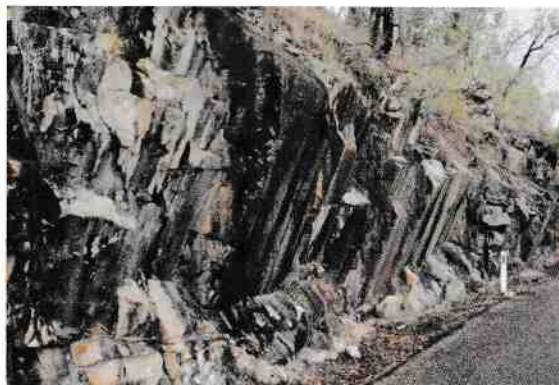
Figure 72 Barrett's Bluff quarry site

Barrett's Bluff, (between Culverts 120 and 119) was the source of the main bridge stone and is a prominent roadside feature with the angled fracture lines of the quarrying process clearly evident as shown in Figure 72. A small, roadside quarry site also exists uphill of Culvert 206A, some of which is contained within the road reserve. Drill marks and large fractured stones are still clearly evident as shown in Figure 73.

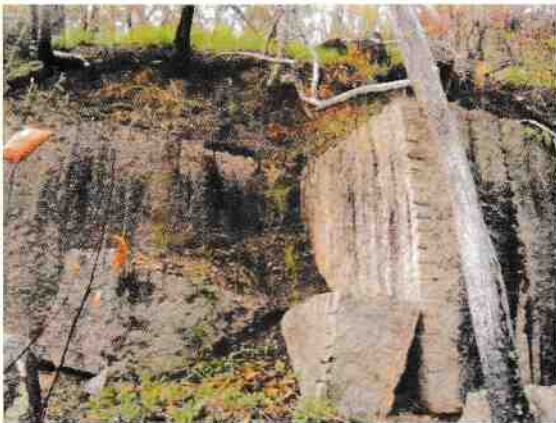
Figure 73 Culvert 206A quarry site

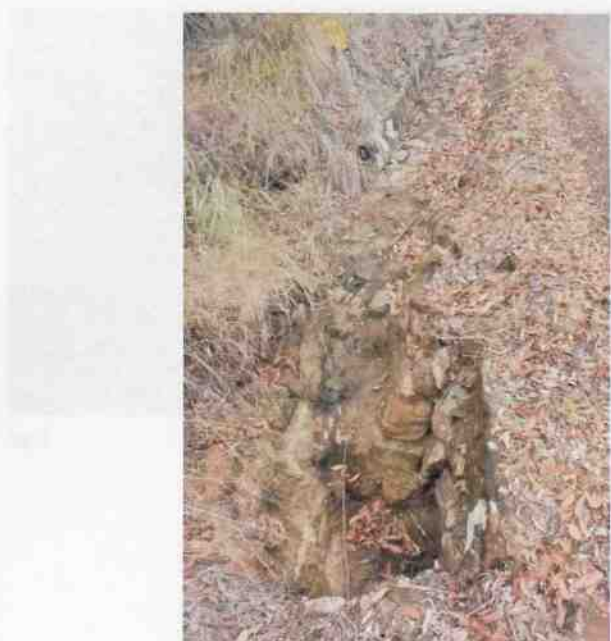
B201

Culvert 109 - Stone kerbing & channelling

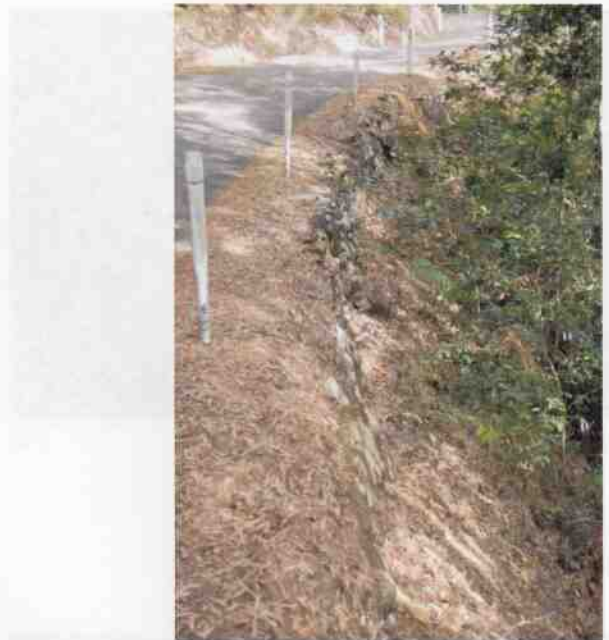
C100

Culvert 62 - E headwall

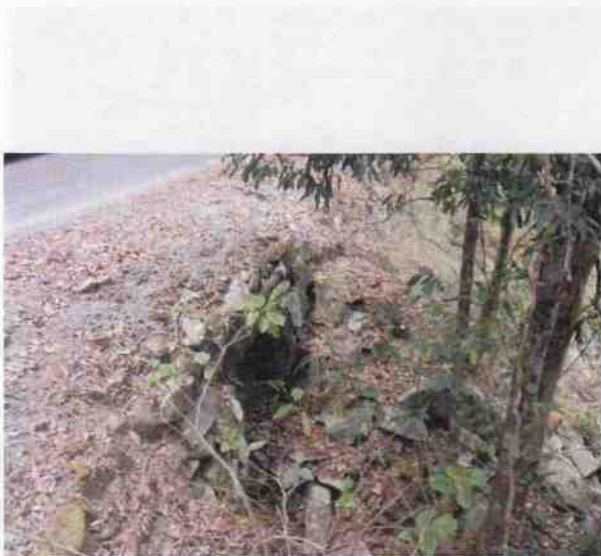
C176

Culvert 25 - E headwall

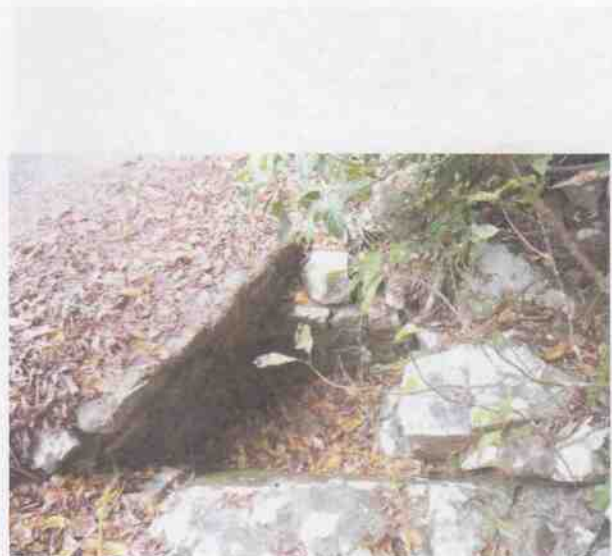
C177

Culvert 25 - U headwall

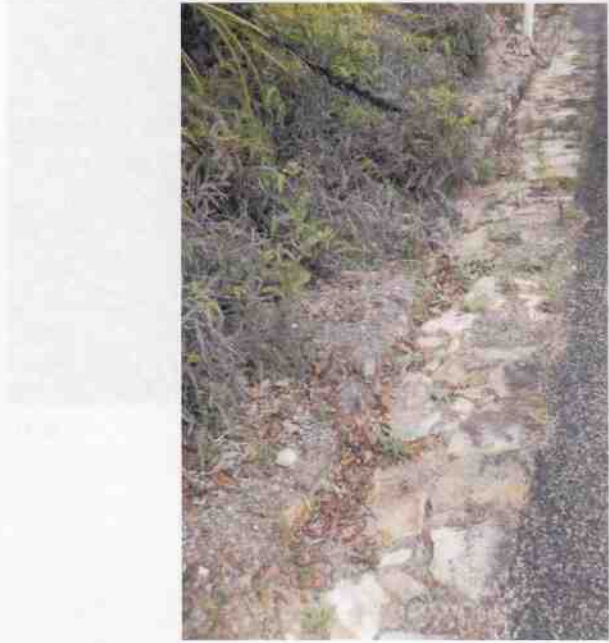
C199

Culvert 15 - Stone kerbing & channelling
